Bulk Jetty, Dublin Port **- pile repairs using concrete encasement**

Consultant: Jacobs

2006

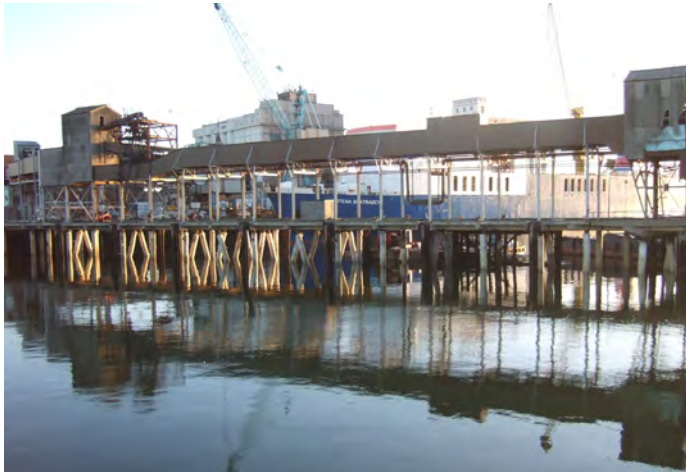
The Bulk Jetty was built in 1950. The steel piles to the jetty were in such a poor condition with many piles holed through corrosion that the structure was considered for demolition. The pile jacket system enabled strengthening and protection by concrete encasement and allowed the jetties use to continue.

The jetty piles had suffered from Accelerated Low Water Corrosion. Following a steel thickness survey and structural appraisal, the Consultant Engineers selected a 100mm thick concrete encasement with weakened lengths to be reinforced with steel sprit rings.

The renox steel section piles were high pressure jet cleaned and inspected before the pile jacket system was applied. 138 piles were protected including raker piles. Pile encasement lengths were typically 9-11m long down to bed level. The top 0.3m of the pile was protected by sprayed concrete onto joint continuity mesh reinforcement. The work was completed in some 7 months, generally using 2 dive teams., putting the jetty back into working condition.
