Consultant: Jacobs

The Bulk Jetty was built in 1950. The steel piles to the jetty were in such a poor condition with many piles holed through corrosion that the structure was considered for demolition. The pile jacket system enabled strengthening and protection by concrete encasement and allowed the continued use of the jetty.

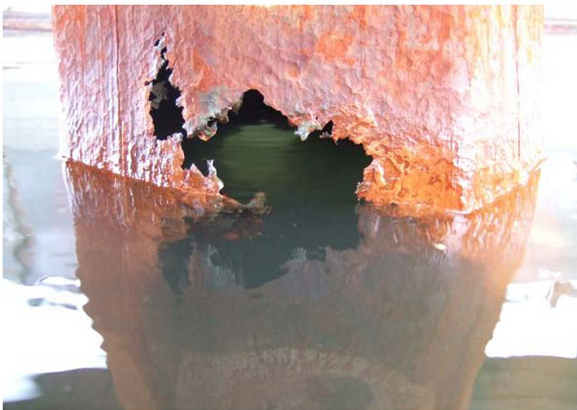
Holed Pile

The jetty piles had suffered from Accelerated Low Water Corrosion. Following a steel thickness survey and structural appraisal, the Consultant Engineers selected a 100mm thick concrete encasement with weakened lengths to be reinforced with steel sprit rings. A traditional 2: 1 sand: cement micro concrete mix was developed to achieve C35 / 45. strength. Polypropylene fibres were included to aid shrinkage control. A site test was conducted on the strengthening arrange to demonstrate the systems use.

The reredoss steel section piles were high pressure jet cleaned and inspected before the pile jacket system was applied. 138 piles were protected including raker piles. Pile encasement lengths were typically 9-11m long down to bed level. The top 0.3m of the pile was protected by sprayed concrete onto joint continuity mesh reinforcement. The work was completed in some 7 months, generally using 2 dive teams, putting the jetty back into working condition.

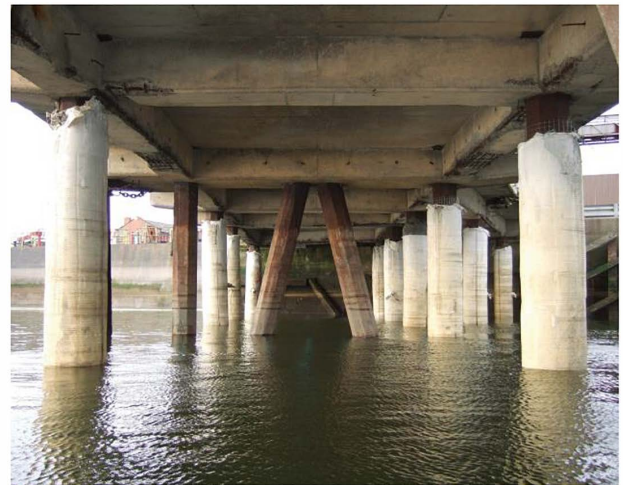
Repaired Piles Using Pile
