Mattress Engineering: Proserve Contractor: Fressinet / Norfolk Marine

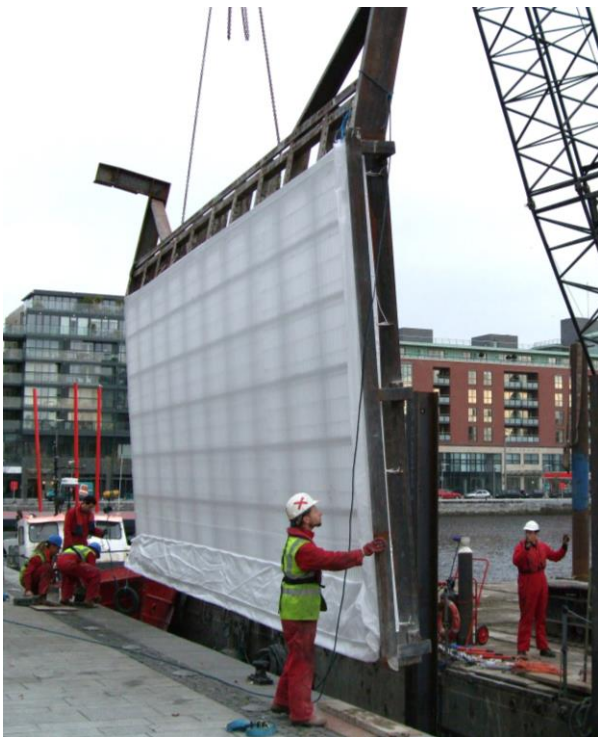
Control Frame Being Craned into Position

The stonework gravity walls to the historic dock basin were suffering from face failure underwater due to loss of its original weak lime mortar. An underwater concrete face repair was selected as the repair method, nominally 100 mm thick. A 10 m long mesh control frame system was adopted which carried a fabric formwork face shutter connected to base and leading side grout bag seals.

The frame was temporarily supported by driven piles with rams to the bottom and drilled anchor ties to the top. The shutter system was filled with a sand: cement micro concrete. The bleed combination of the micro concrete mix and fabric face formwork quickly reduces concrete filling pressures and allows a lower weight frame system to be used. It also produced a good quality concrete face repair which also infilled failed stonework areas.
