CASE STUDY: PITTENWEEM HARBOUR BREAKWATER | UK | 2015-2016

Engineer: AECOM Mattress Engineering: Proserve Contractor: Farrans / Aberdeen Marine Services

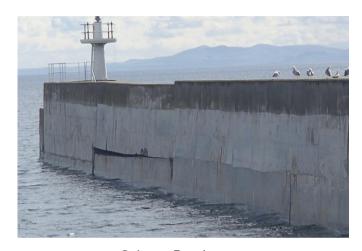
Caisson Breakwater

The concrete caisson breakwater extension at Pittenweem had suffered base underscour and failure of the foundation bedding stone, causing settlement of caisson 3 of some 0.2m.

The foundation was reinstated by underbase grouting of the caissons, assisted by Proserve's grout bag perimeter seals, along with subsequent pattern grouting of the caisson fill.

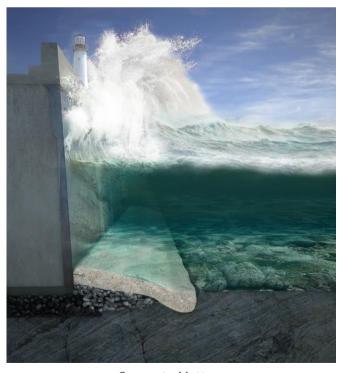
Concrete Mattress

CT1000 mattress, 1.0 m thick was installed to the outer breakwater, for wave action of 4.5 m. Mattress edges were toed into the variable mudstone/sandstone bedrock to protect edges from future scour. The mattress was tied into the breakwater wall using heavy steel pins to resist breaking wave loads.

CT480 mattress, 0.5 m thick was installed to the inner face of the breakwater, for lesser wave action and local fishing vessel traffic.

Concrete mattresses were fabricated in compartments of 10 m³ filling volume for constructability, with robust ball and socket shear joints between panels.

The concrete mattress panels were filled in situ with highly fluid sand:cement micro concrete delivered by ready-mix. The mix was pumped using a Putzmeister 1000D piston pump up to 270 m along the breakwater in 100 mm steel pipes, into a secondary worm pump at the worksite with 50 mm rubber grouting hose for diver handling.
