# Marine Pile Repairs by Concrete Encasement

**Martin Hawkswood**, Proserve Limited, Kenilworth, UK

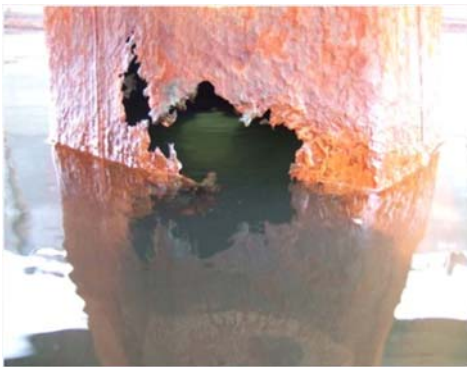
Fig. 1 – ALWC Damage.  
Dublin Jetty

Many steel piles suffer from Accelerated Low Water Corrosion (ALWC) or Anaerobic Corrosion with significant section loss well before the design life of the structure expires (Fig. 1). Port Owners and Engineers should respond by monitoring corrosion and steel thickness loss and provide appropriate protection or repair.

The ‘Briefing Sheets’<sup>7,8</sup> and the ‘Port Designers Handbook’<sup>1</sup> outline the expected causes of Anaerobic Corrosion and ALWC. Anaerobic corrosion is caused by microbic action and typically displays a bright orange corrosion product with general section loss throughout the water depth (Lerwick), although occasionally it is found in isolated patches. ALWC occurs at just above the low water zone (LAT) due to oxidation corrosion forming layers of rust laminates. Fig 1 demonstrates ALWC after pile cleaning.

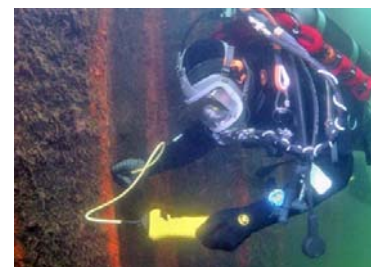
Fig. 4 – Thickness Monitoring

When corrosion loss becomes significant relative to the design allowance, a full diver survey through the water column and up to the deck is advisable. Thickness readings should be at closer centres to areas of critical loss (usually to low water zone) and then adjusted to locate the areas of maximum section loss. H piles or Rendex piles (welded sheet pile sections, Lerwick & Dublin Port) should be checked on all flat and weld elements due to differing corrosion performance. Extruded steel circular piles are typically checked on 4 sides to critical areas.

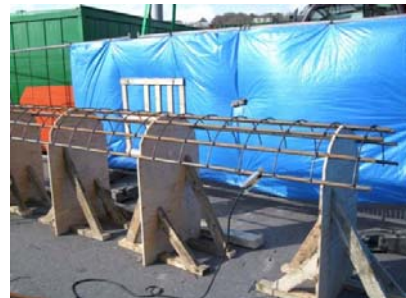
Fig. 5 – Reinforcement Cage

section basis<sup>9</sup>. For ease of application, reinforcement is usually designed in 2 half cages which are accurately fabricated for relatively easy assembly round the pile with loose curved overlap links fixed by diver to link them together (Fig. 5).

Strengthening reinforcement within the concrete encasement can be designed as required to cover the defective pile length. As previously described, reinforcement cages should be designed in two accurately made halves which can be readily linked together by divers using curved links (Fig 5 & 20).

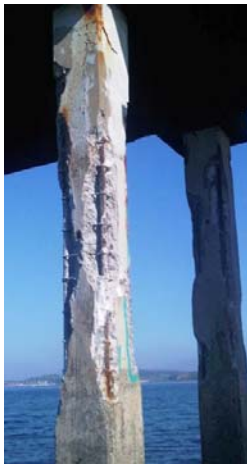
Fig. 7 - Damaged R.C. Pile, Hunterston

Damage to sections is normally caused by surface carbonation of the concrete with the penetration of chlorides (readily present in sea water) promoting rusting of the reinforcement and subsequent cracking and spalling of the concrete cover. Generally damage has occurred from just below low water (LAT) through the tidal zone and lessening into the splash zone (Fig. 7). Reinforcement corrosion is not generally found in the continuous immersion zone.

The jetty piles had been suffering from reinforcement corrosion within the tidal range.(Fig. 7) Repairs currently underway are using a reinforced concrete encasement (Fig. 20). Preparation is by hydro demolition. The micro concrete mix is a 2:1 sand: cement mix, 40 N/ mm<sup>2</sup> (C32/ 40) with polypropylene fibres with 50 mm cover provided to new reinforcement.
