Grout Bag Engineering: Proserve Contractor: Mota-Engil.

Proserve's armour repair grout bag system was used to form in situ concrete infill repairs to voids in Accropode II revetment protection on the island of Fogo, Cape Verde. 8 No voids were filled using the system, using grout bags of 6 m³ volume. The grout bags were pump filled in situ with highly fluid sand:cement micro concrete to repair interlock and stability between Accropodes.

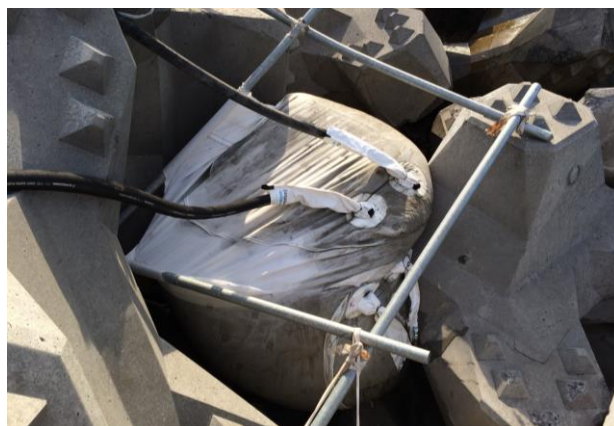
Grout Bag Held in Position

The grout bags were positioned into the voids, temporarily supported by scaffold tubes, and filled in situ with the fluid micro concrete mix. Surplus grout bag fabric allowed the concrete to adequately fill the space in the void and form concrete interlock with neighboring Accropodes.

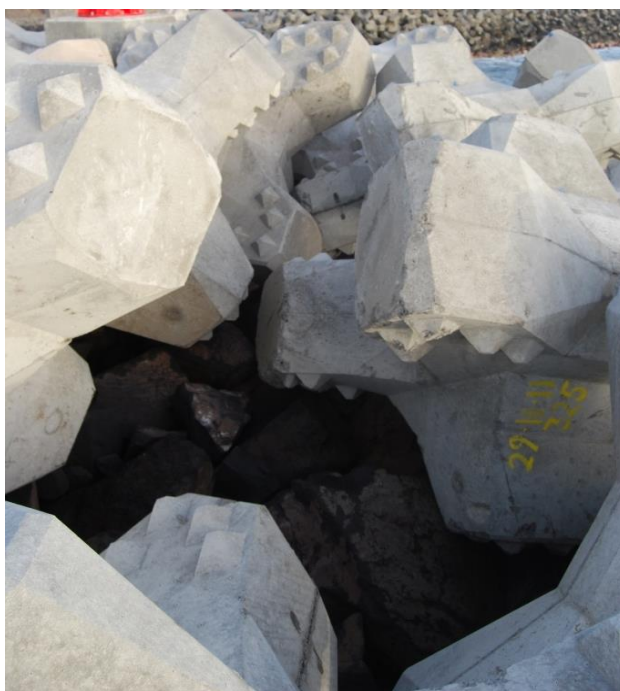
Void between Accropode II units
